**US Army Corps
of Engineers®**
Engineer Research and
Development Center

Fluvial Instability and Channel Degradation of Amite River and its Tributaries, Southwest Mississippi and Southeast Louisiana

D. Ryan Hood, David M. Patrick, and Maureen K. Corcoran

September 2007

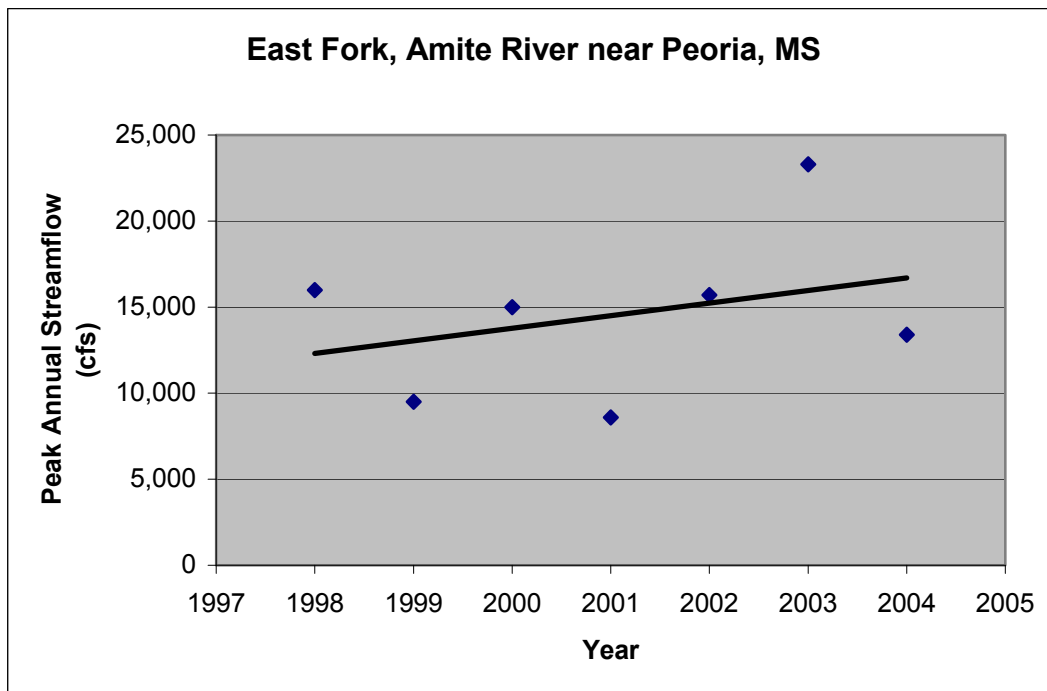
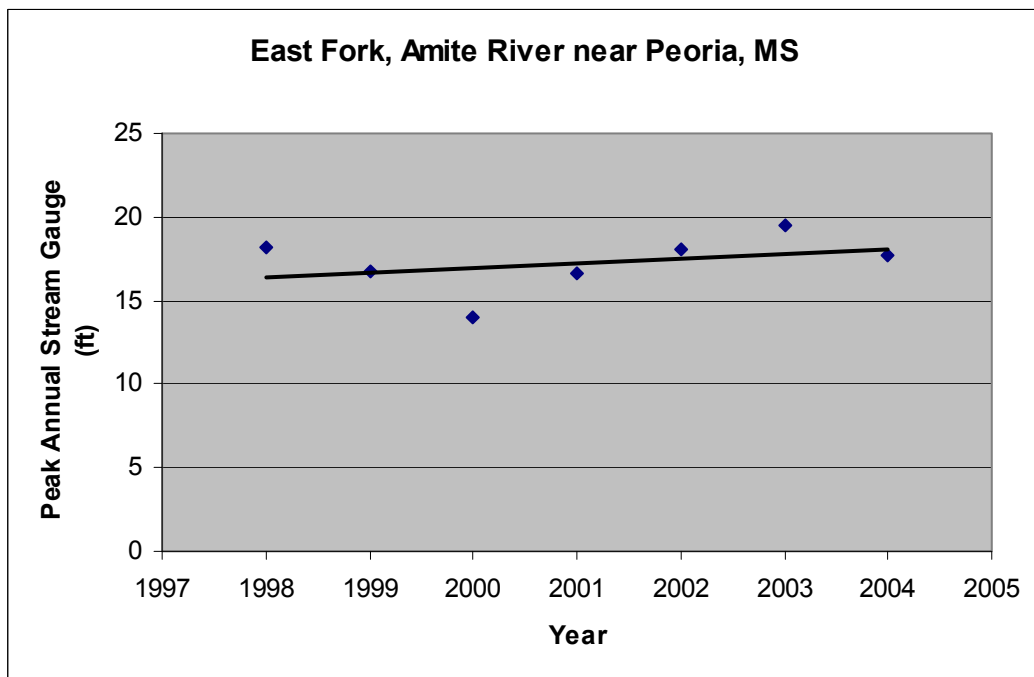
This gauge station is the only current station in the Amite River headwaters and is the most recently established station within the basin. Peak annual streamflow and peak annual gauge height data are shown in Figure 122. Mean annual streamflow data were not available. These gauge data, as well as that of subsequently described stations, are scattered and

the regression lines should be considered approximate. The data in Figure 122 suggest that both peak annual streamflow and peak annual gauge height increased over the last several years.

Figure 122. Peak annual streamflow (a) and peak annual gauge height (b), East Fork of the Amite River near Peoria, MS.

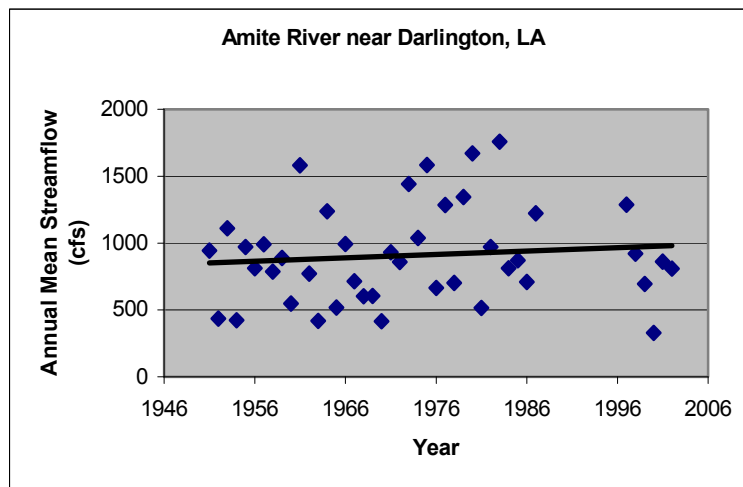
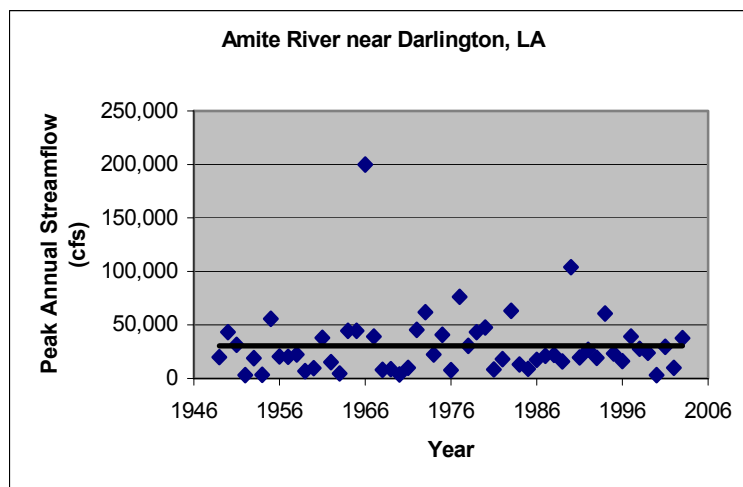
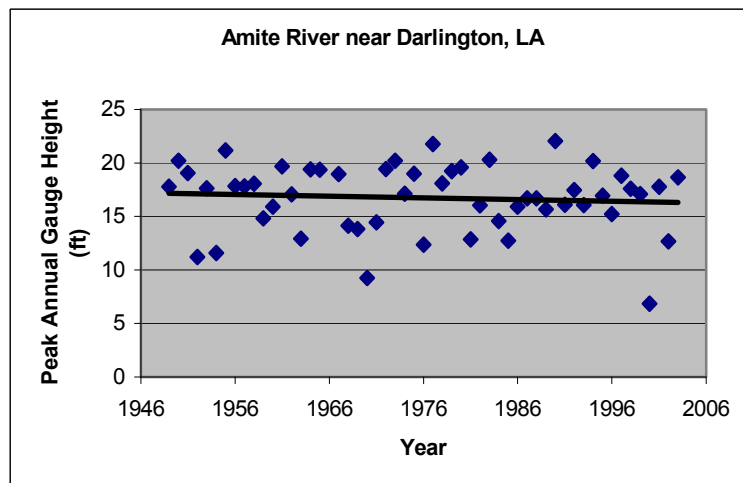
This station is the most northerly station on the Amite River in Louisiana and is located upstream of the principal mined reaches. Gauge data shown in Figure 123 indicate a slight annual mean streamflow increase (Figure 123a), constant peak annual streamflow (Figure 123b), and a decrease in peak annual gauge height (Figure 123c). This bridge failed in 1999 during which both the peak annual streamflow and the peak annual gauge height were not particularly high.

Figure 123. Annual mean streamflow (a), annual peak streamflow (b), and peak annual gauge height (c) for the Amite River at the Louisiana Highway 10 crossing near Darlington, LA. The Darlington flood stage is 7.27 ft.

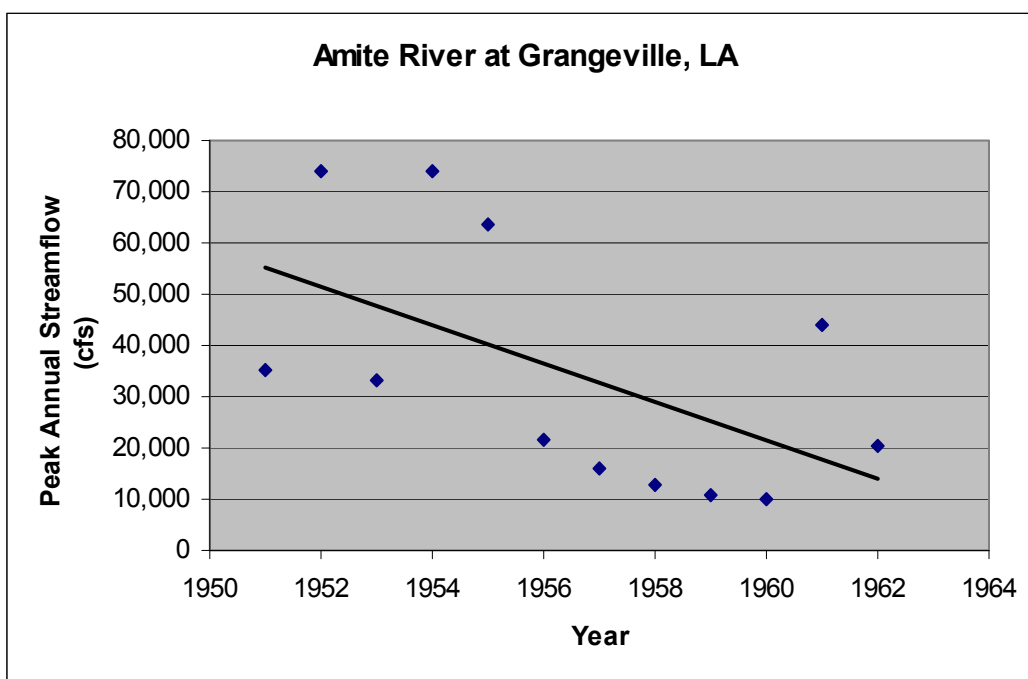
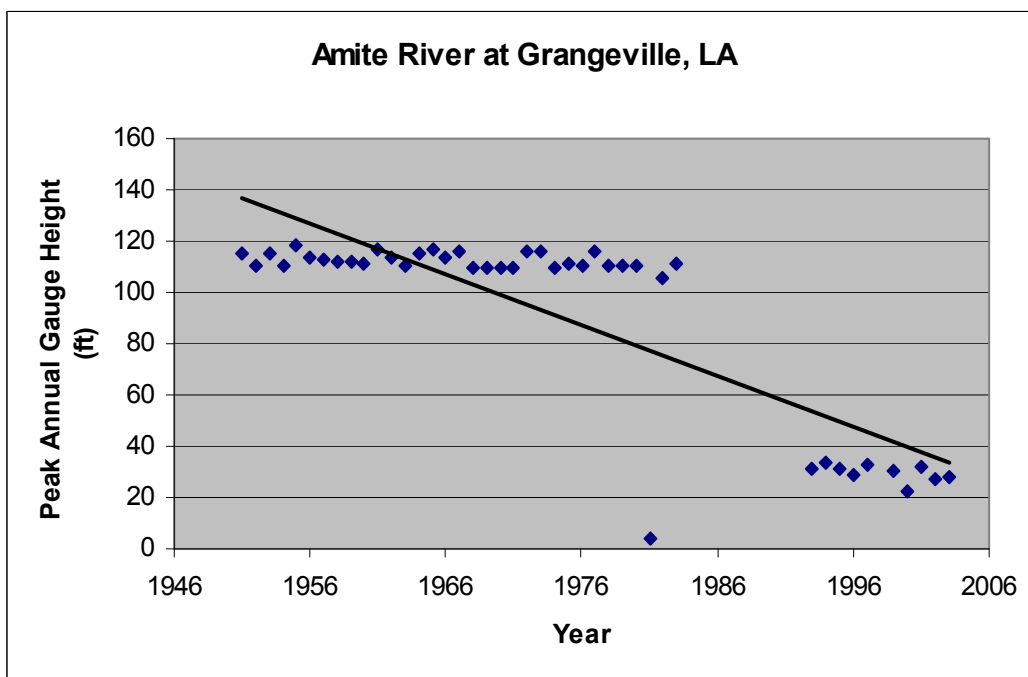
This gauge station is located near the center of the principal mined reach. Peak annual streamflow and peak annual gauge height are shown in Figure 124. Peak annual streamflow was recorded from the early 1950s

through the early 1960s (Figure 124a) and exhibits a significant decrease in streamflow. Peak annual gauge height also decreased after the mid-1980s. Both decreases may be attributable to the widening of the channel by mining.

Figure 124. Peak annual streamflow (a) and peak annual gauge height (b) for the Amite River at the Louisiana Highway 37 Bridge Crossing near Grangeville, LA. The flood stage at this station is approximately 35 ft.

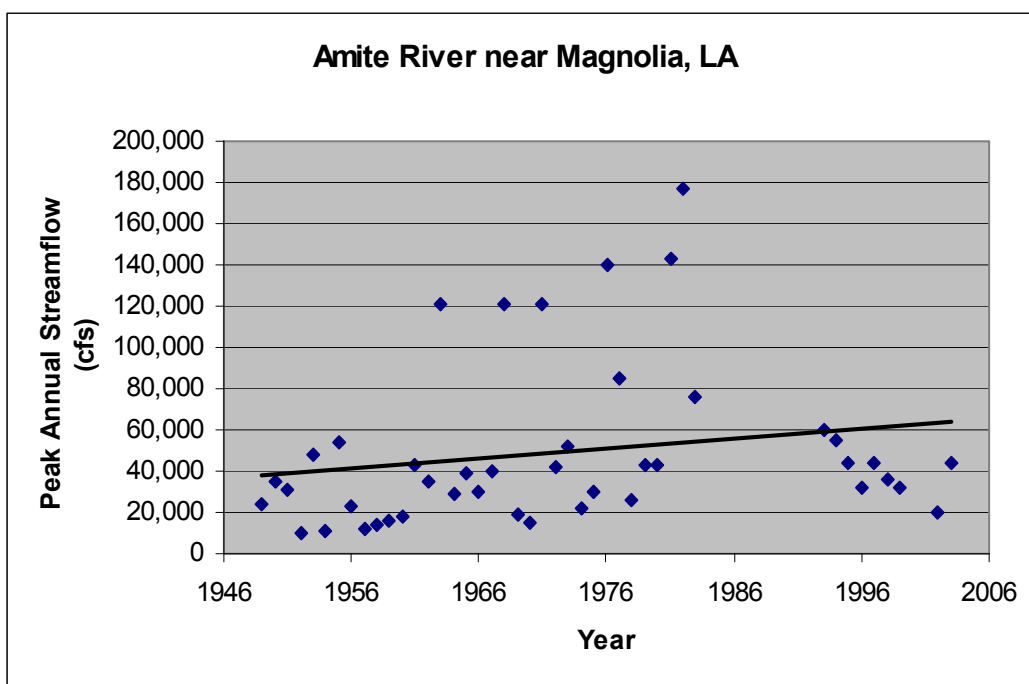
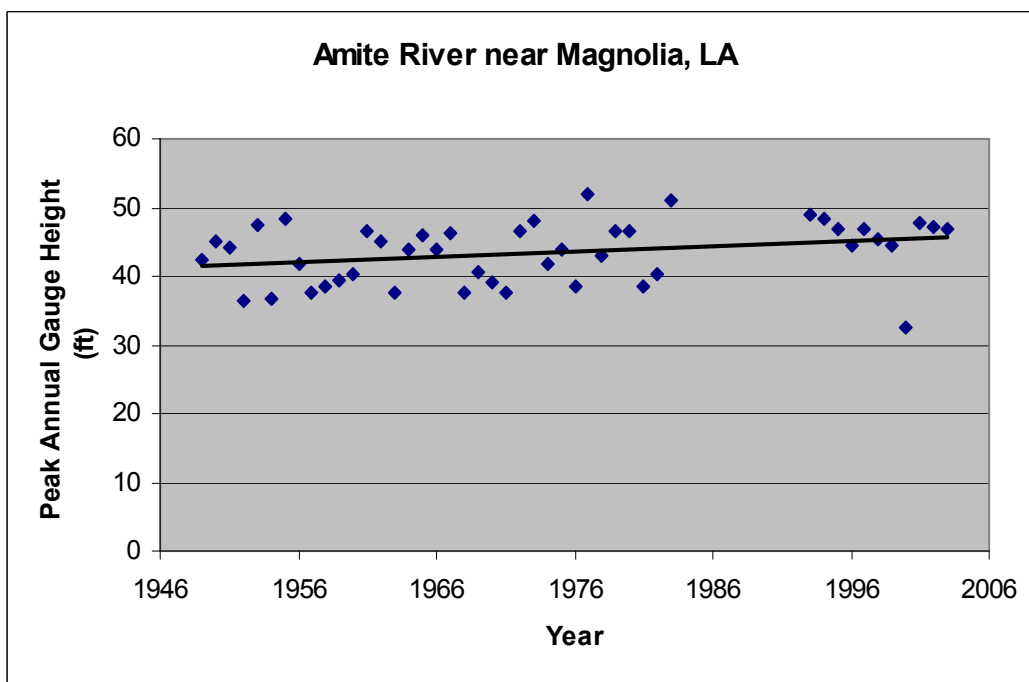
This gauge is located downstream of the principal mined reach, but there are scattered mines both upstream and downstream of this gauge station. Peak annual streamflow and peak annual gauge height trends (Figure 125) both exhibit increases with time. This trend is particularly apparent for peak annual gauge height.

Figure 125. Peak annual streamflow (a) and peak annual gauge height (b) for the Amite River at the Louisiana Highway 64 Bridge Crossing near Magnolia, LA. The flood stage at this station is 34.66 ft (NGVD).

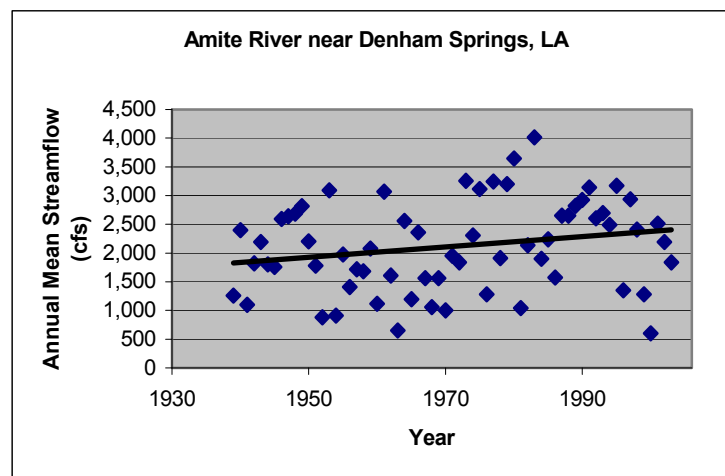
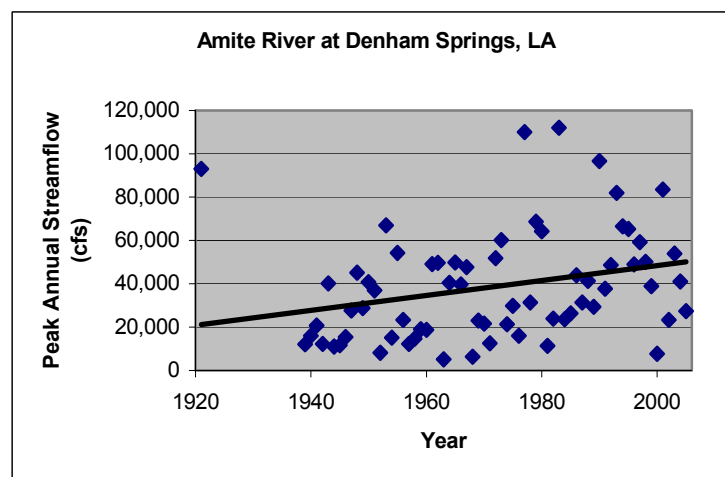
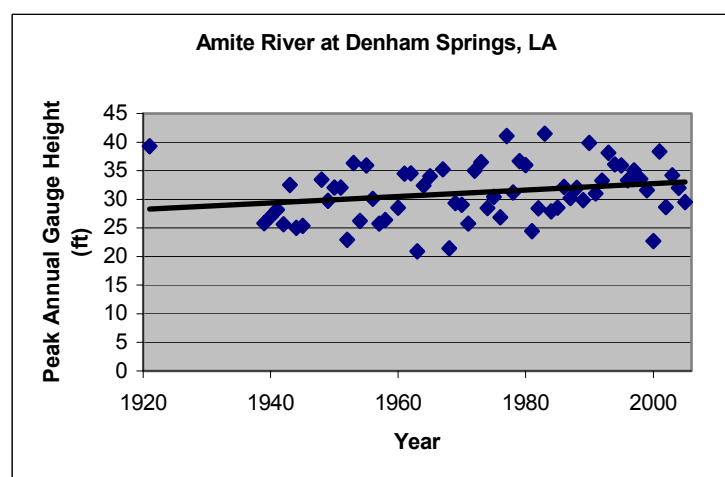
Figure 126 shows the annual mean streamflow (a), peak annual streamflow (b), and peak annual gauge height (c) all of which, particularly peak gauge height, exhibit trends, which increase with time. This site is located in an urbanized area, which includes Denham Springs to the east and Baton Rouge to the west.

Figure 126. Annual mean streamflow (a), peak annual streamflow (b), and peak annual gauge height (c) for the Amite River at the Louisiana Highway 190 Bridge crossing near Denham Springs, LA. The flood stage at this station is 20.81 ft (NGVD).

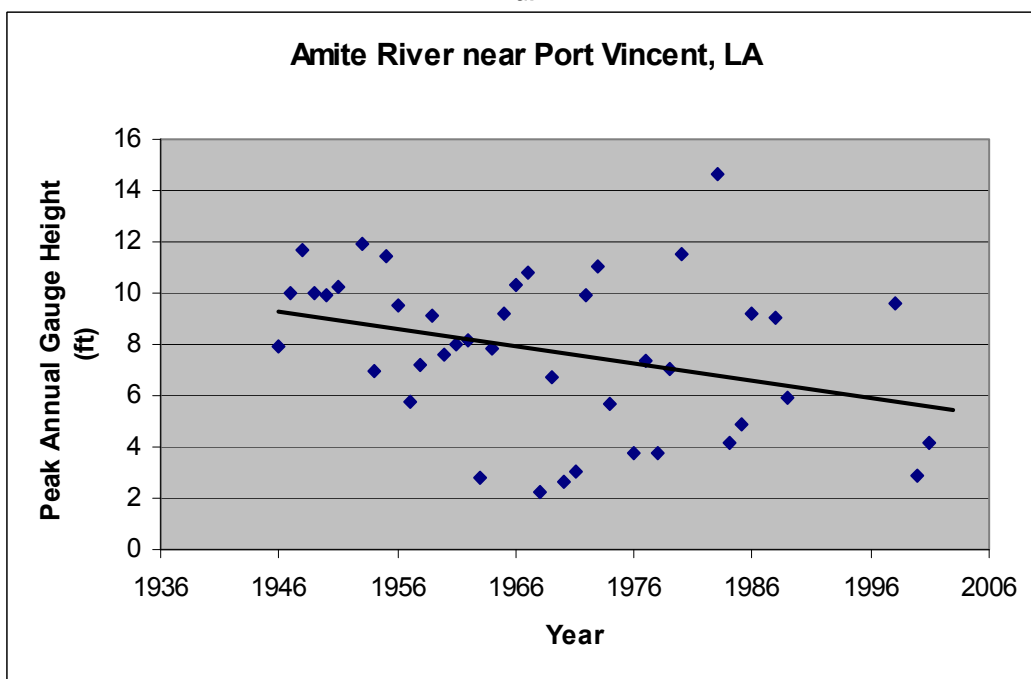
This site is located upstream of the Amite River Diversion Canal and available gauge data are shown in Figure 127. Trend data for both peak annual streamflow (Figure 127a) and peak annual gauge height (Figure 127b) decrease with time. These decreases are probably due to the diversion canal.

Figure 127. Peak annual streamflow (a) and peak annual gauge height (b) of the Amite River at the Louisiana Highway 42 Bridge crossing at Port Vincent, LA. The flood stage at this station is 3.54 ft (NGVD).

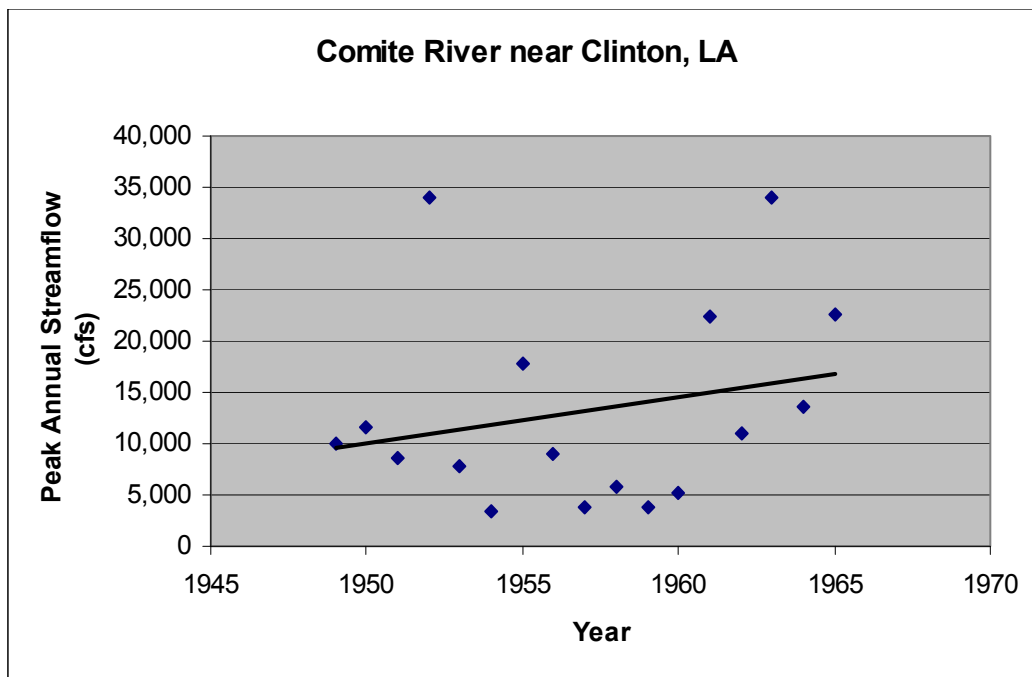
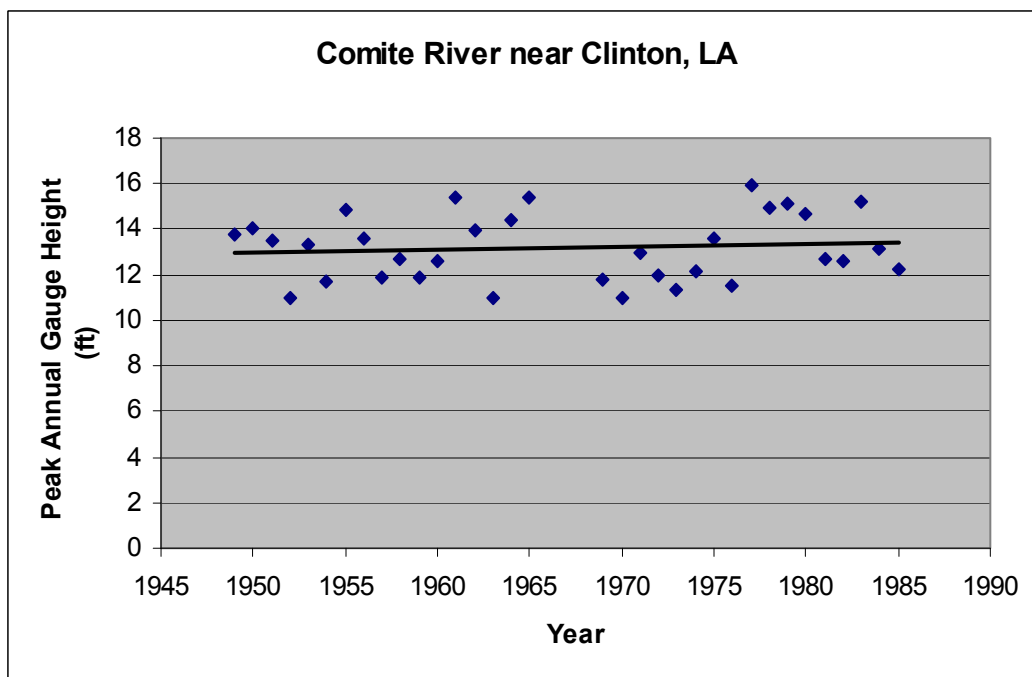
This station is located in a mainly rural area and is furthest upstream station in the Comite River Basin. Peak annual streamflow data (Figure 128a) are incomplete so the trend line is not significant. However, peak annual gauge height data (Figure 128b) are complete and indicate virtually no change over time.

discharge seen on the Olive Branch gauge may indicate that there may be some significance to the peak annual streamflow trend line shown in Figure 128a at the Clinton gauge upstream.

Figure 128. Peak annual streamflow (a) and peak annual gauge height (b) for the Comite River and Louisiana Highway 10 Bridge crossing near Clinton, LA.

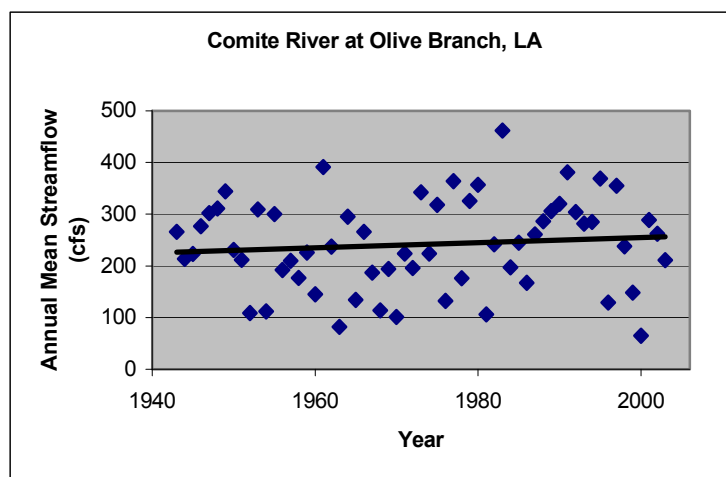
This station is located in a predominantly rural area. Gauge data are given in Figure 129. Both annual mean (Figure 129a) and peak annual streamflow (Figure 129b) have increased over time, whereas peak annual gauge height (Figure 129c) has decreased over time. A temporal increase in stream discharge accompanied by decreased gauge height is most likely an indication of channel erosion. Furthermore, an increase in stream

Figure 129. Annual mean streamflow (a), peak annual streamflow (b), and peak annual gauge height (c) of the Comite River at the Louisiana Highway 67 Bridge crossing near Olive Branch, LA.

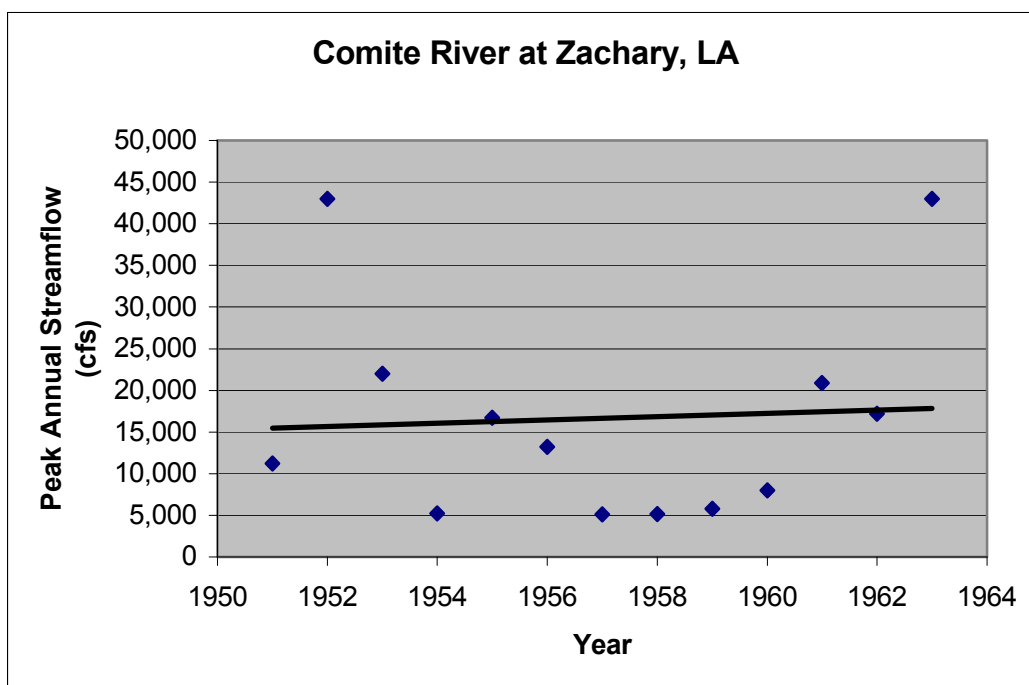
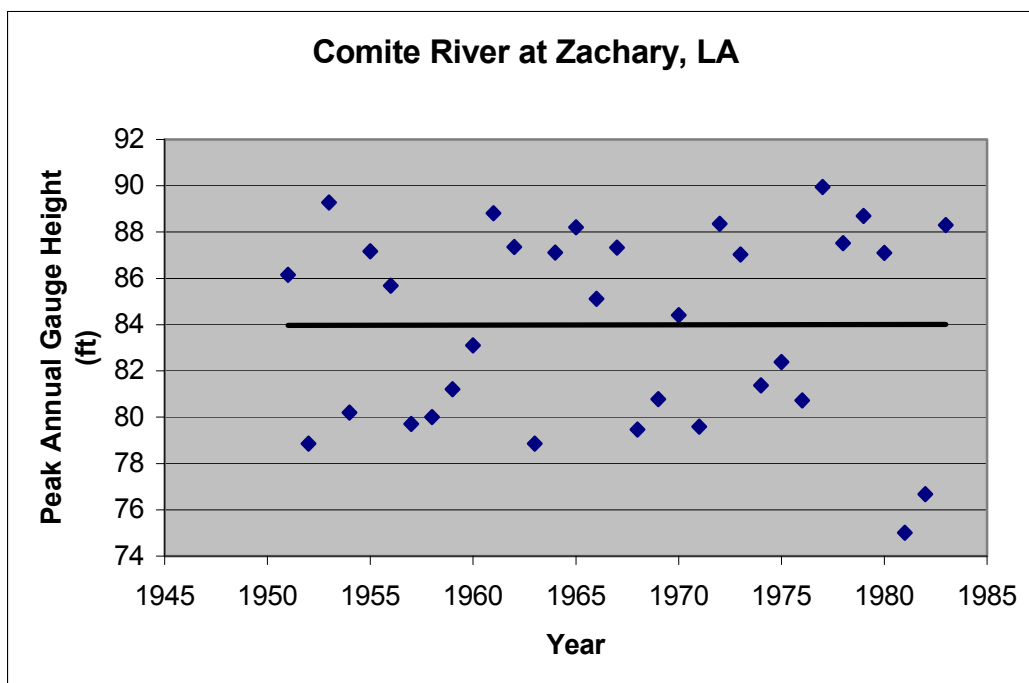
This gauge station is also located in a rural area. Gauge data shown in Figure 130a are incomplete but there is an indication of an increase in peak annual streamflow over time; however, the peak annual gauge height (Figure 130b) has remain relatively constant.

Figure 130. Peak annual streamflow (a) and peak annual gauge height (b) for the Comite River at the Louisiana Highway 64 Bridge crossing near Zachary, LA.

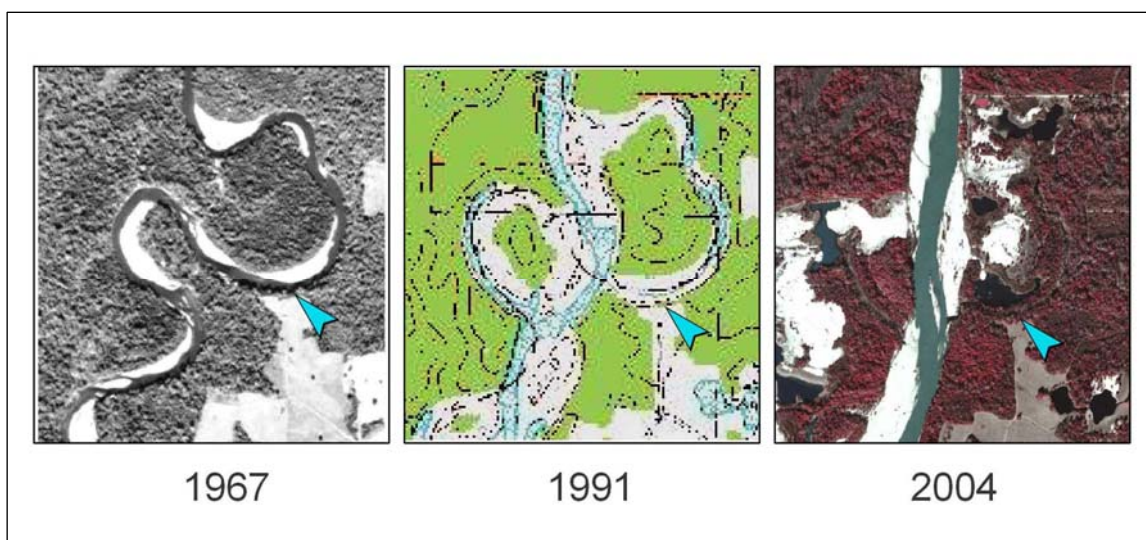
Data from field studies, imagery and bridge surveys indicate significant erosion and changes in stream planform. These changes may be summarized by direct comparison of the planform of the river pre-mining versus successive periods of time as shown in Figure 132. The illustrated area is along a mined reach upstream of Grangeville, LA, and due east of Gilead, LA. The pre-mining image (1967) illustrates well-developed point bars and well-vegetated cut banks. The post-1967 views reveal an increase in point bar size and by 1991, significant cutoffs on the meander bends. By 2004, the river had changed from meandering to nearly straight having been reduced in length by approximately 27 to 29 percent. Imagery and bridge survey data, as well as field data, indicate that the channel has become wider by as much as 233 percent. Bridge survey data, however, do not indicate significant change in channel bed elevation at the crossing sites. Another result, derived from these data, is that the gradient of the channel has increased due to decreased sinuosity. The bank erosion has, thus, been caused by increased water velocity due to the increased gradient.

Figure 132. Planform changes exhibited by the Amite River since the pre-mining period in 1967 (aerial photo), after mining commenced during 1991 (topographic map) and 2004 (Atlas satellite image). Arrows indicate matchpoints on the maps and imagery.

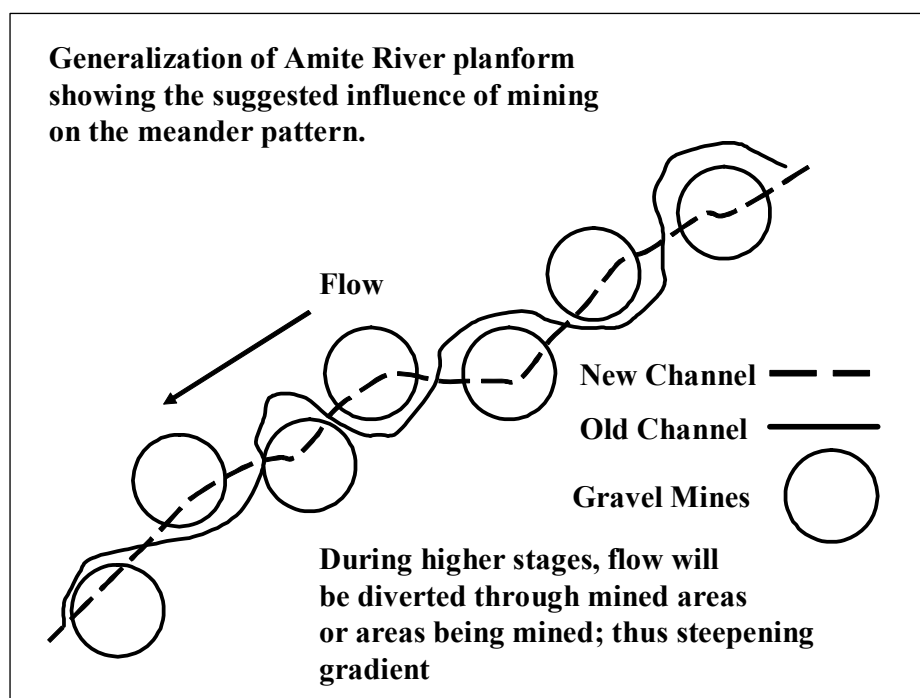
Field studies and imagery have shown that reaches of the river occupy mined areas, divided flow exists in the channel, and bank erosion occurs on both sides of the channel. These data suggest that changes in planform may be explained by breaching of the mined areas during high river stages as shown in Figure 133. The former thalweg of the river is shown as a solid line and the former or current mined areas shown as circles. During high stages the river shifts into the mined areas (dashed line) similar to a natural meander cutoff. The channel shift results in straightening of the river, higher water velocity, and increased erosion on both sides of the channel. The changes in planform and gradient exhibited on the Amite River appear similar to those described by Smith and Winkley (1996) on the Lower Mississippi River and attributed to artificial cutoffs.

Figure 133. Proposed explanation of planform changes due to mining.

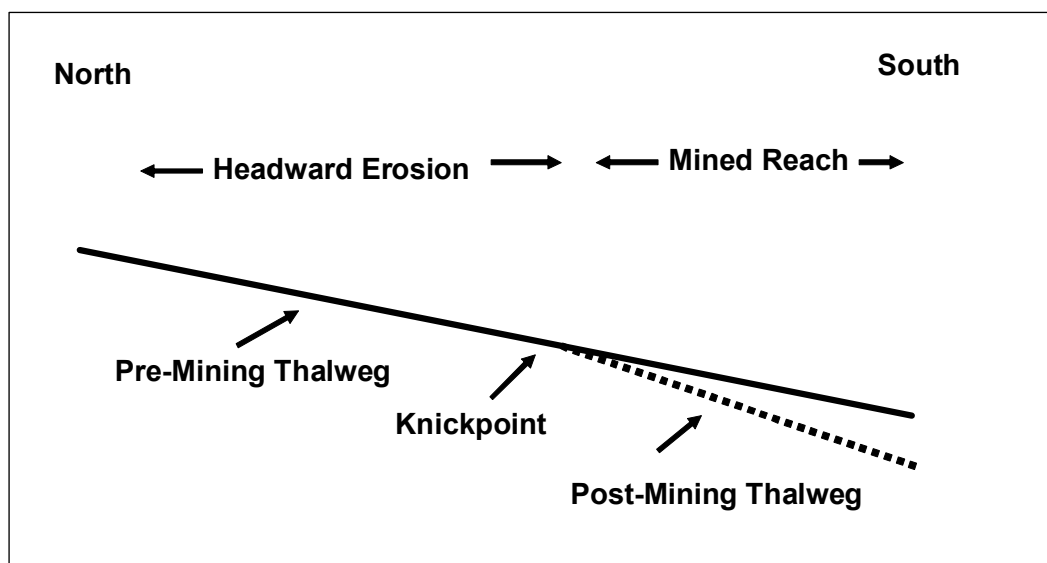
Field studies and imagery have shown that erosion occurred on the main stem of the Amite River upstream of the mined reach and on the tributaries as well. Imagery demonstrated that the stream length decreased by approximately 5 percent in the vicinity of the East Fork and West Fork confluence and at Felixville, the channel width has increased by 25 percent. These data indicate that there has been an increase in channel gradient along this upstream reach. As in the case of the tributaries along the mined reach, a knickpoint was formed and headward erosion progressed upstream as shown in Figure 135.

Figure 135. Generalized north-south cross-section of the Amite River showing the knickpoint resulting from the steepened gradient on the mined reach.
